# **Case Summary Report**

## Examining A 1930's Restoration of the

## Winooski River Watershed, Vermont

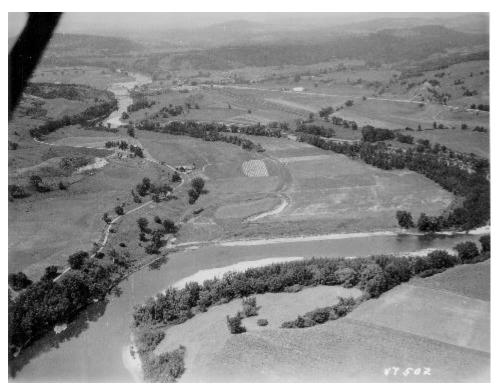
(Photo 2 CD)

Figure 1. Watershed treatments are readily apparent after two years (July, 1940). Compare this to figure 2, before. Formerly eroded hillsides to the right are no longer visible. The broad gap in the forested riparian corridor (lower center) has been planted to trees (200 feet wide strip) and the eroded streambank and flood chute have been treated using soil bioengineering.

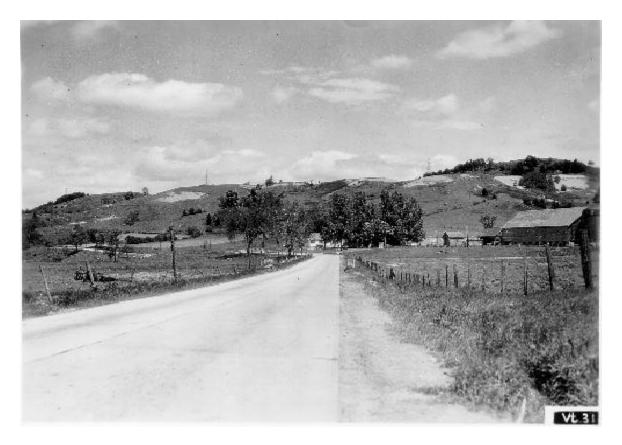
Figure 2. Landscape before the project (1936). A mild, long drought, overgrazing and poor farm management turned these hilly pastures into large sandblows, while floods ravaged the bottomlands

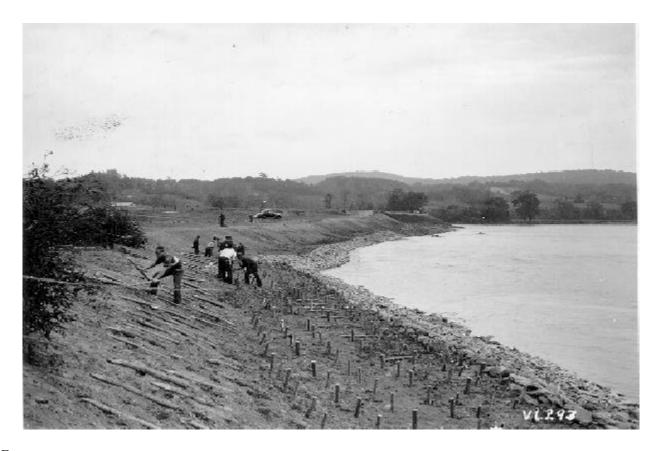
Figure 3. Most treatment measures required extensive plant materials and hand labor. Workers are installing live willow stakes and brush matting on a terraced streambank (September, 1938). (Photo 22 CD)

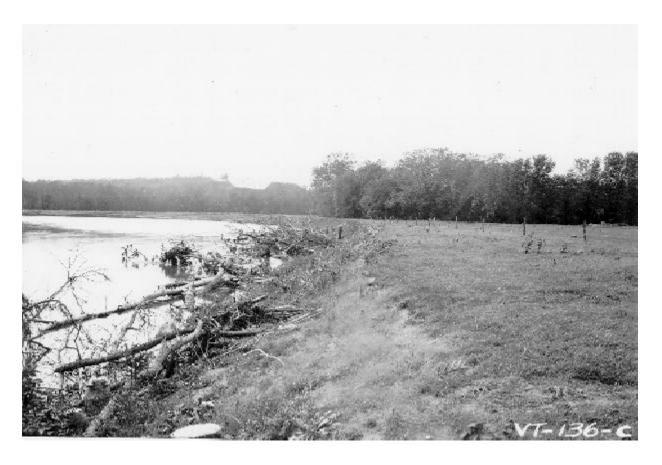
Figure 4. A previously, heavily-grazed streambank was fenced (right) to exclude livestock . Tree revetment (left center) was installed 8 months prior to this photo and had just endured a 10 year-flood. (September, 1938) ( $Photo\ 52\ CD$ )

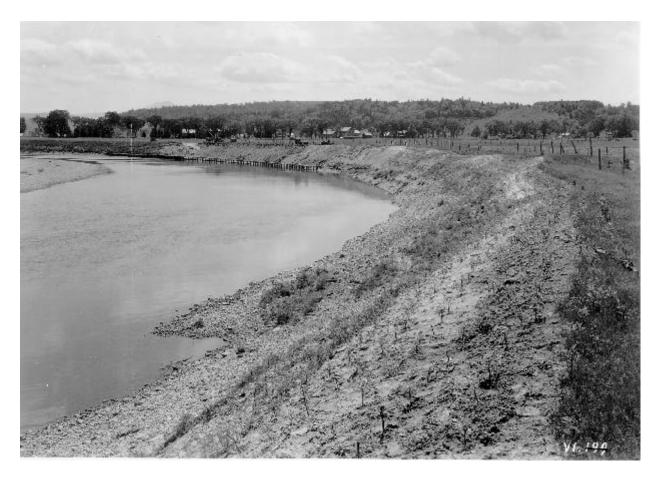
Figure 5. Sloped bank 2 months after planting with willow cuttings (June, 1938). Elaborate piling network at channel toe in background failed completely in eight years from ice action and bank seepage. ( $Photo\ 47\ CD$ )

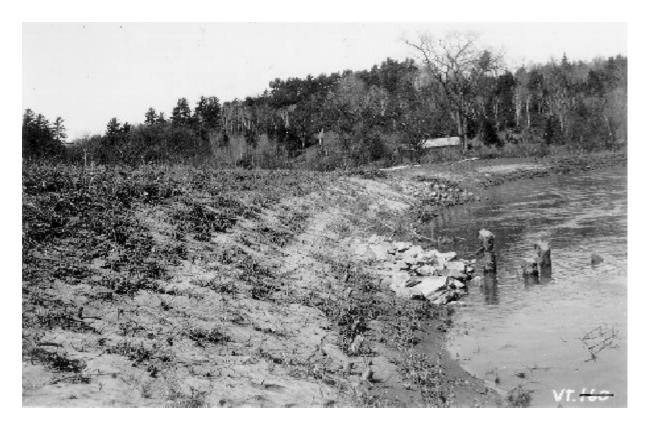
Figure 6. A severely eroded slope has been shaped, planted to red osier dogwood and willow and brush- matted using live willow stakes (note in foreground). Pile jetties have also been installed intermittently at the toe. (Mar., 1938). (Photo 67 CD)

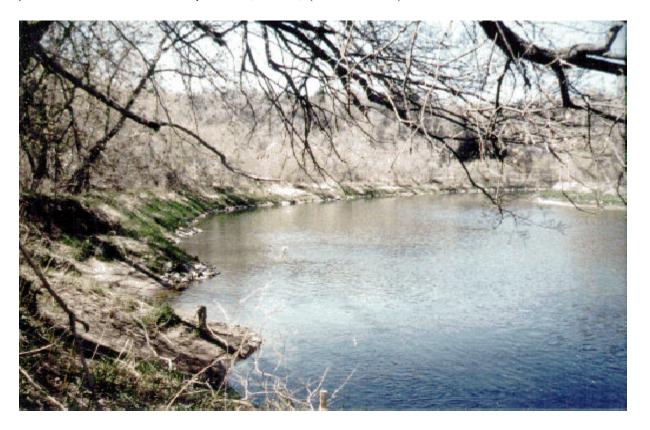
Figure 7. Same vantage point as figure 6, taken April, 1995. Note the large trees on the upper bank. The lower bank which receives substantial ice flows remains intact and well established with grasses and shrubs. ( $Photo\ 68\ CD$ )

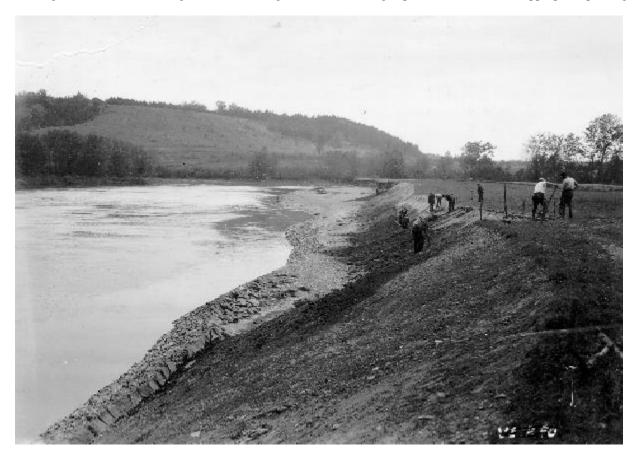
Figure 8. Workers prepare slope for brushmatting and planting of willows (September, 1938). Rock riprap has been hand placed at toe of slope. (Photo 33 CD)

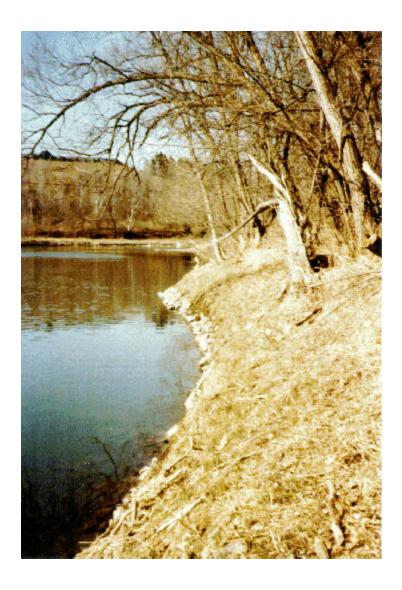
Figure 9. Same site as Figure 8 taken in April, 1995. Note the height and trunk diameter of the willows. (Photo 35 CD)

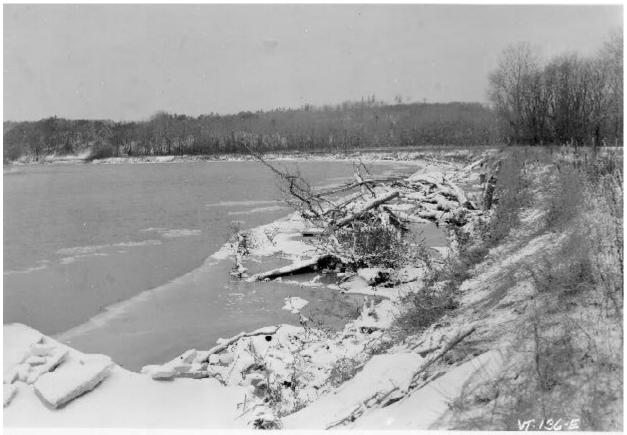
Figure 10. Whole tree deflectors after three years of installation (January, 1941). Compare to 'after' installation in Figure 4. Note the sediment accumulation and growth that has occurred among the trees as well as the bank. Ice as seen here was a major nuisance to some installations. ( $Photo 54\ CD$ )

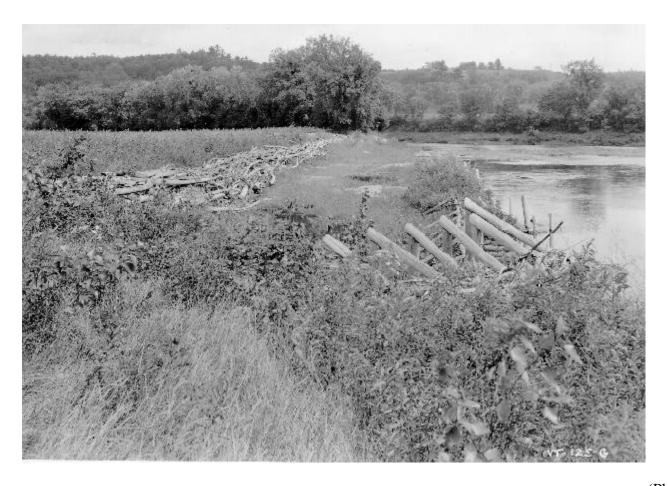
Figure 11. Looking downstream towards log pile check dam to the right; whole tree barricade, left center; and buffer plantings, far left (August, 1941). ( $Photo\ 100\ CD$ )

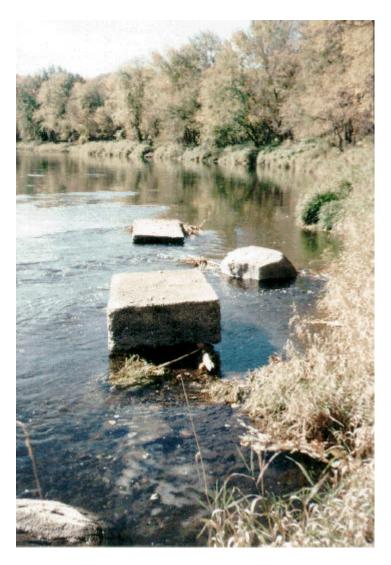
Figure 12. Looking upstream along same river reach as Figure 11(Fall, 1994). The blocks in foreground were ballast to the tree barricades, long gone from the system. Note the well established, mature buffer plantings and intact streambank. The buffer plantings have held and are now mature trees, right. (Photo 101 CD)

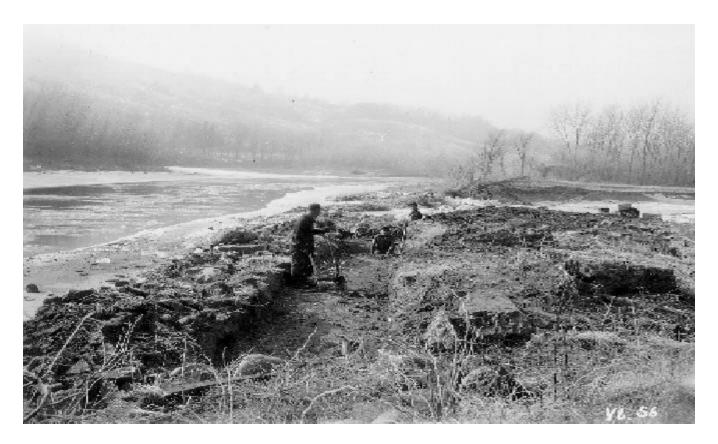
Figure 13. Workers preparing subgrade for stone-filled log crib to close a severe flood chute gap (upper right). (January, 1937) ( $Photo\ 86\ CD$ )

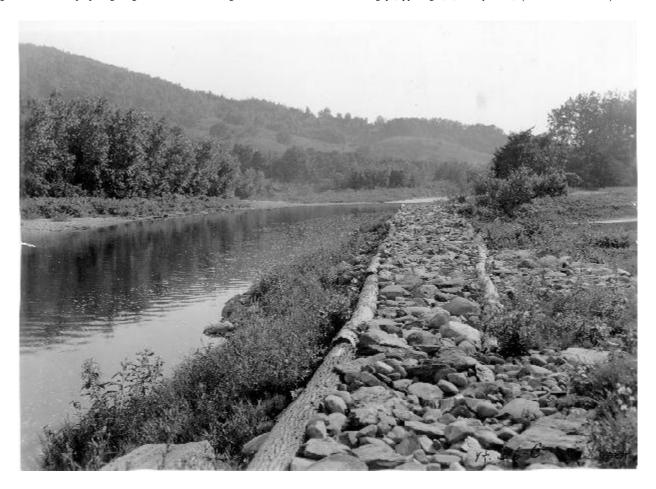
Figure 14. Streambank with stone-filled log crib of Figure 13, after bank and buffer plantings, July, 1937. (Photo 87 CD)

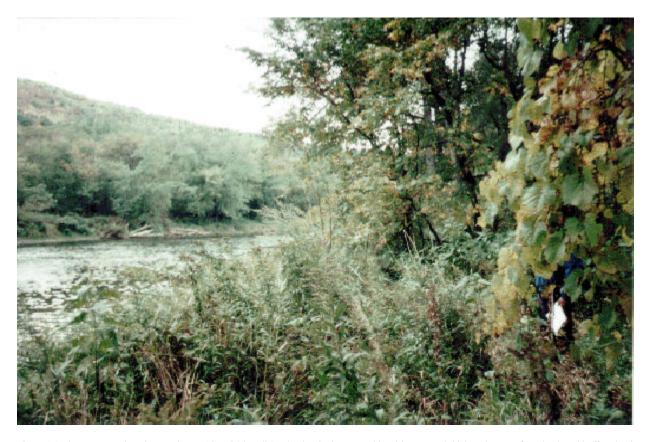
Figure 15. Photo at same location as Figures 13 and 14, Fall 1994. The site is very stable with trees and thick understory from bank and buffer plantings. (Photo 89 CD)

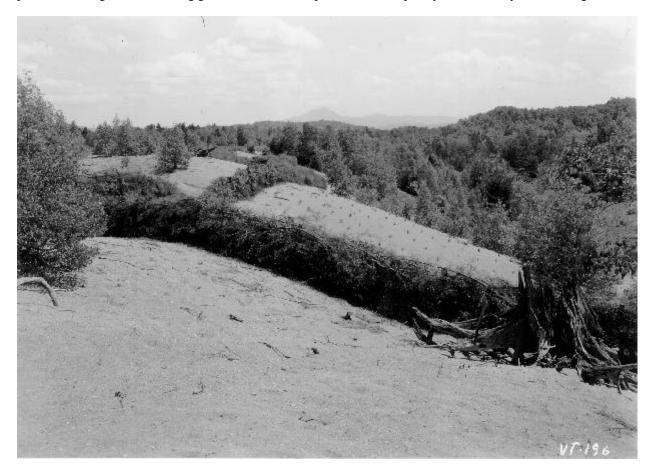
Figure 16. A pasture in the watershed uplands shortly after treatment, June 1938. Brush fences, center, were placed to reduce wind effects while tree plantings became established. Note nearly all topsoil is missing.  $(Photo\ 126\ CD)$

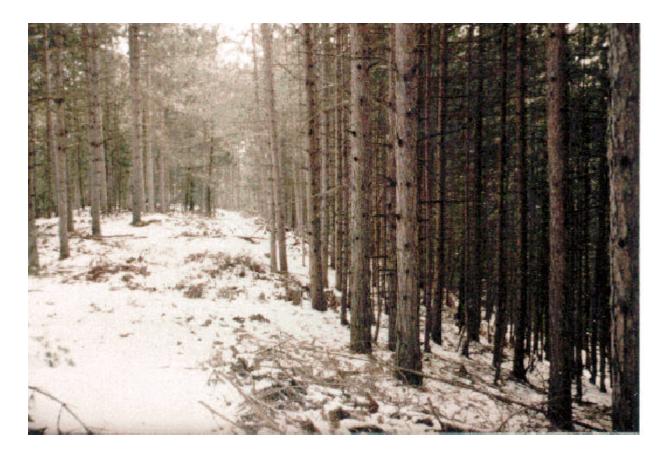
Today sampling of these sites shows a soil organic layer of from 3 to 12 inches on previously sand blown areas. Healthy vegetative overstory exists with heights ranging from 60 to 100 feet, and native species, such as sugar maple are returning.

Figure 17. The same location as Figure 16 in February, 1996 showing the heavy, red pine plantings and forest floor mantle. Topsoil is now 3 to 12 inches deep. (Photo 127 CD)

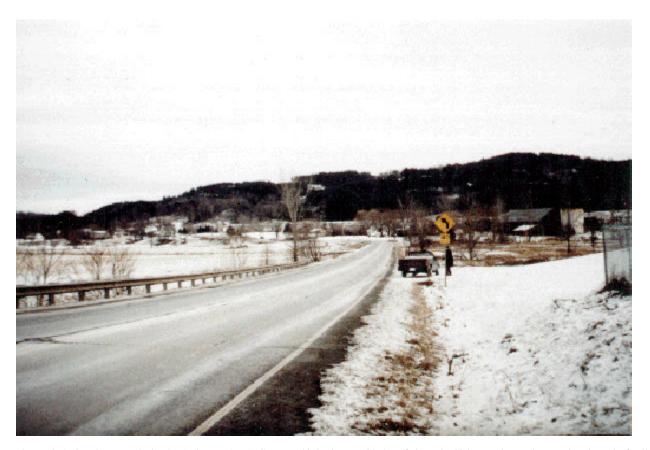
Figure 18. A changing watershed today (February, 1996). Compare this landscape with that of Figure 2 which was taken at the same location. The fragile, forested uplands that resulted from project treatment are now threatened by rapid development which has potential for cumulative impacts on the watershed. (Photo 132 CD)
